# BOTTOM BRACKET SHAFT TEST FOR E-BIKE TORQUE SENSORS

Defective bottom bracket shafts can impair the measurement accuracy of e-bike torque sensors. Magneto-inductive structure and crack testing with MAGNATEST D reliably inspects the shafts.

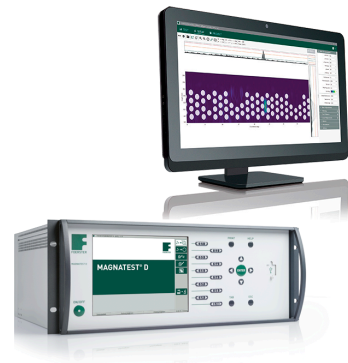
FOERSTER has developed a multi-stage test cell for production environments. The process includes component identification, demagnetization with EMAG, residual field C-scan, magneto-inductive microstructure testing using MAGNATEST D with dual fork probe, surface scanning for defects, and optical inspection. The modular setup can be integrated inline or operated as a stand-alone system.
