# WALL THICKNESS INSPECTION OF TURBINE BLADES

Material degradation in turbine blades can compromise safety and efficiency in aerospace and power generation. Automated MAGNETOSCOP testing reliably evaluates wall thickness before components return to service.

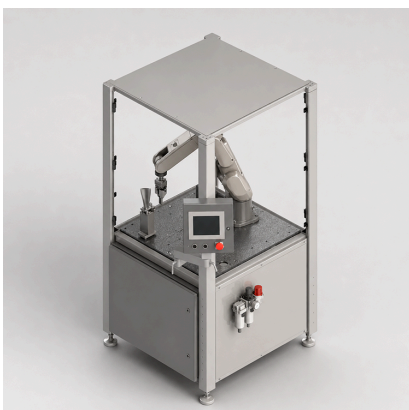
The system integrates MAGNETOSCOP into a robotic inspection cell for automated wall thickness evaluation. A specially designed, non-magnetic probe holder made from 3D-printed plastics prevents magnetic disturbance near the sensor. The robot guides each blade to defined inspection zones, and measurement data are recorded and linked to the part's serial number for full traceability.
