## Automated Crack and Structure Testing of Valves

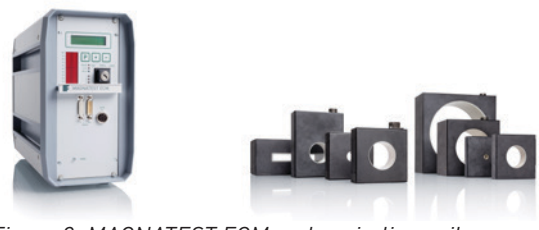
For hardness testing of the valve stem, a magnetoinductive test method can additionally be used. The required module of the MAGNATEST product family can be easily combined with the STATOGRAPH.

Figure 3: MAGNATEST ECM and encircling coils

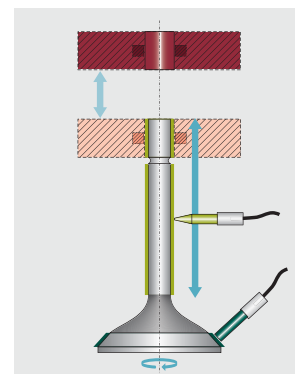
During combined crack detection and hardness testing, the crack detection probes scan the critical parts of the components. For this purpose, the probes can be adjusted to the respective testing area and can either be traversed or can be stationary. For non-destructive inspection of the heat treatment condition, an additional encircling testing coil is used on the valve stem (see Figure 4)

Figure 4: Testing principle
