Automated Crack Detection of Brake Discs

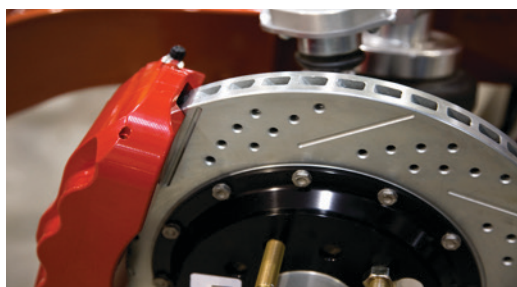
Figure 1: Brake disc

Brake discs are one of the safety-relevant components of a vehicle. Therefore, the highest demands are placed on the material used. The material must withstand both high mechanical and thermal loads during braking. For this reason, it must be ensured that only fault-free material is installed.

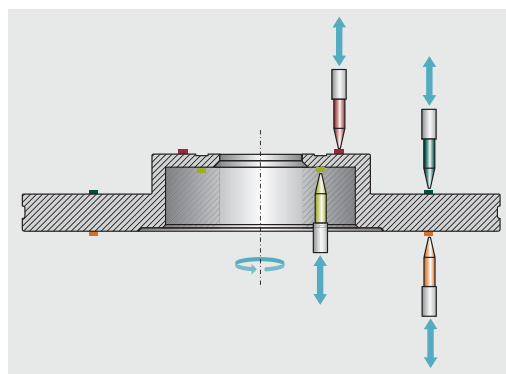
Figure 3: Testing principle

Figure 3 shows a schematic drawing of a brake disc being tested. In this case, the testing concept has been adapted to the requirements of the testing job so that four separate probes scan the relevant testing zones of the brake disc. These probes can be adapted per customer specifications to the respective material in order to enable a sensitive and reproducible test. The use of several test modules results in a multi-channel solution working at a high clock speed.

During testing, defined, fault-prone zones of the the braking surface and bolting surface are examined both on the outside and inside of the brake disc. The automatic testing allows a high throughput speed of about 240 parts per hour.
